NACA TN 2052

EFFECTS OF AN AGING TREATMENT ON LIFE OF SMALL  
CAST VITALLIUM GAS-TURBINE BLADES

By Charles A. Hoffman and Charles Yaker

Lewis Flight Propulsion Laboratory  
Cleveland, Ohio

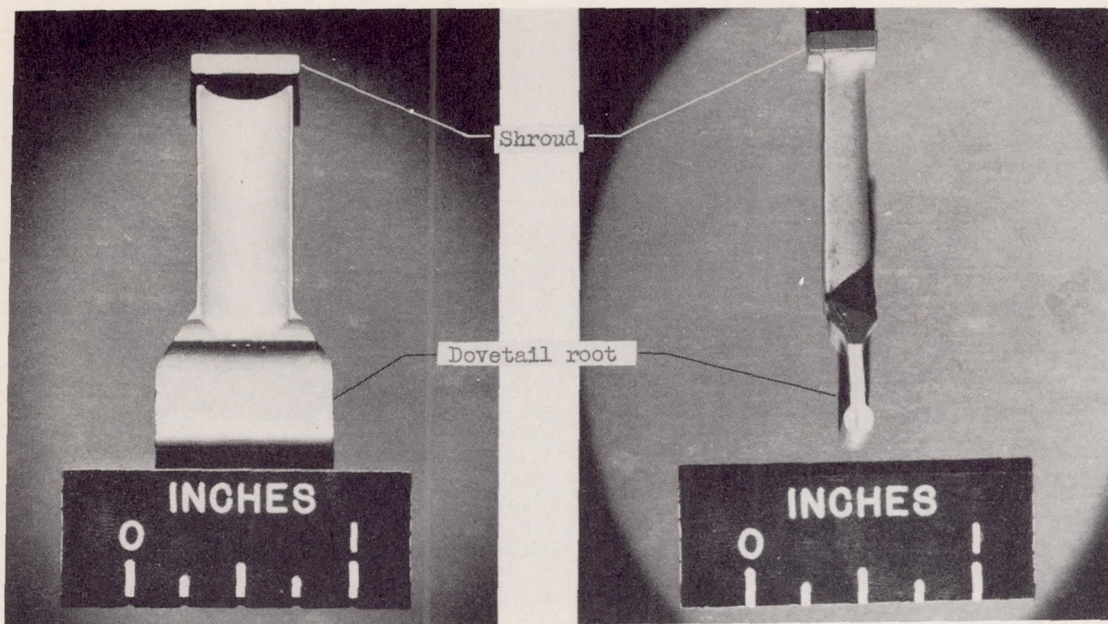
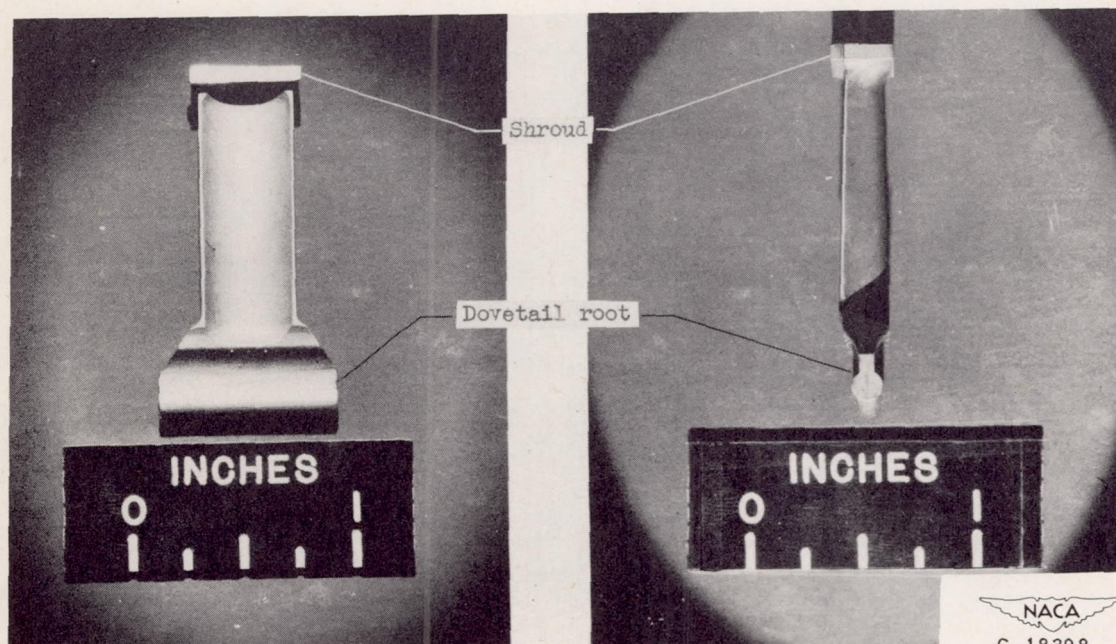
Figure 1. - Typical gas-turbine blades.

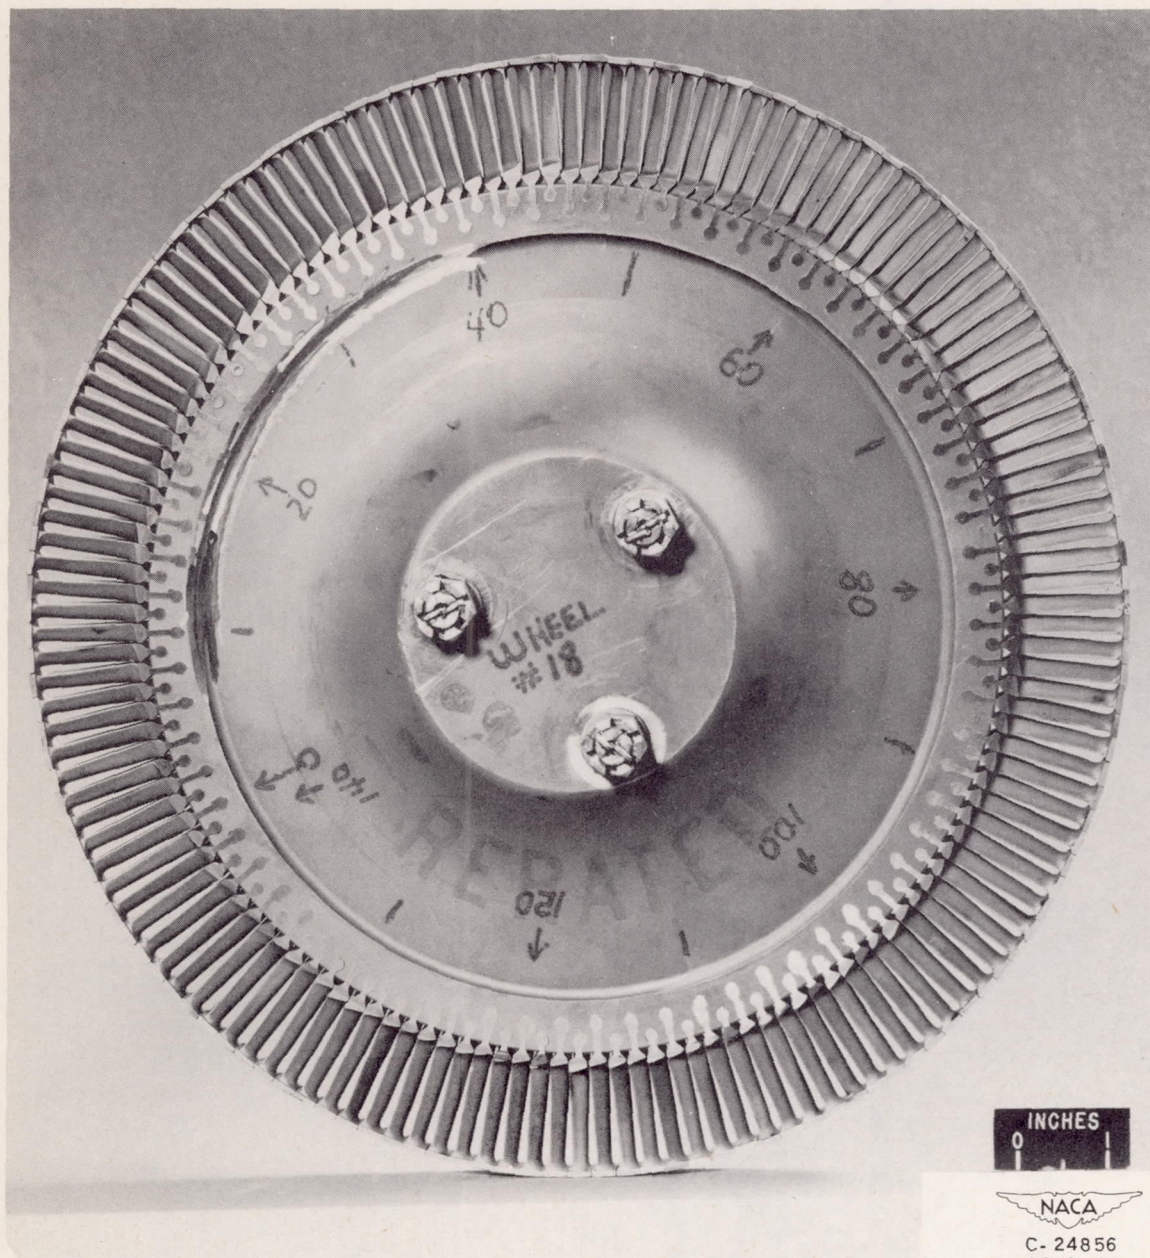
The turbine wheel was  $9\frac{1}{2}$  inches in diameter and the blades extended  $1\frac{1}{2}$  inches beyond the wheel periphery. The turbine wheel, which mounted 142 blades, is shown in figure 2. The 20 aged blades and 33 unaged blades were located at approximately equal intervals about the wheel periphery. The remaining blades in the wheel functioned only to preserve the operating characteristics of the wheel.

Figure 2. - Assembly of turbine wheel and blades before operation.

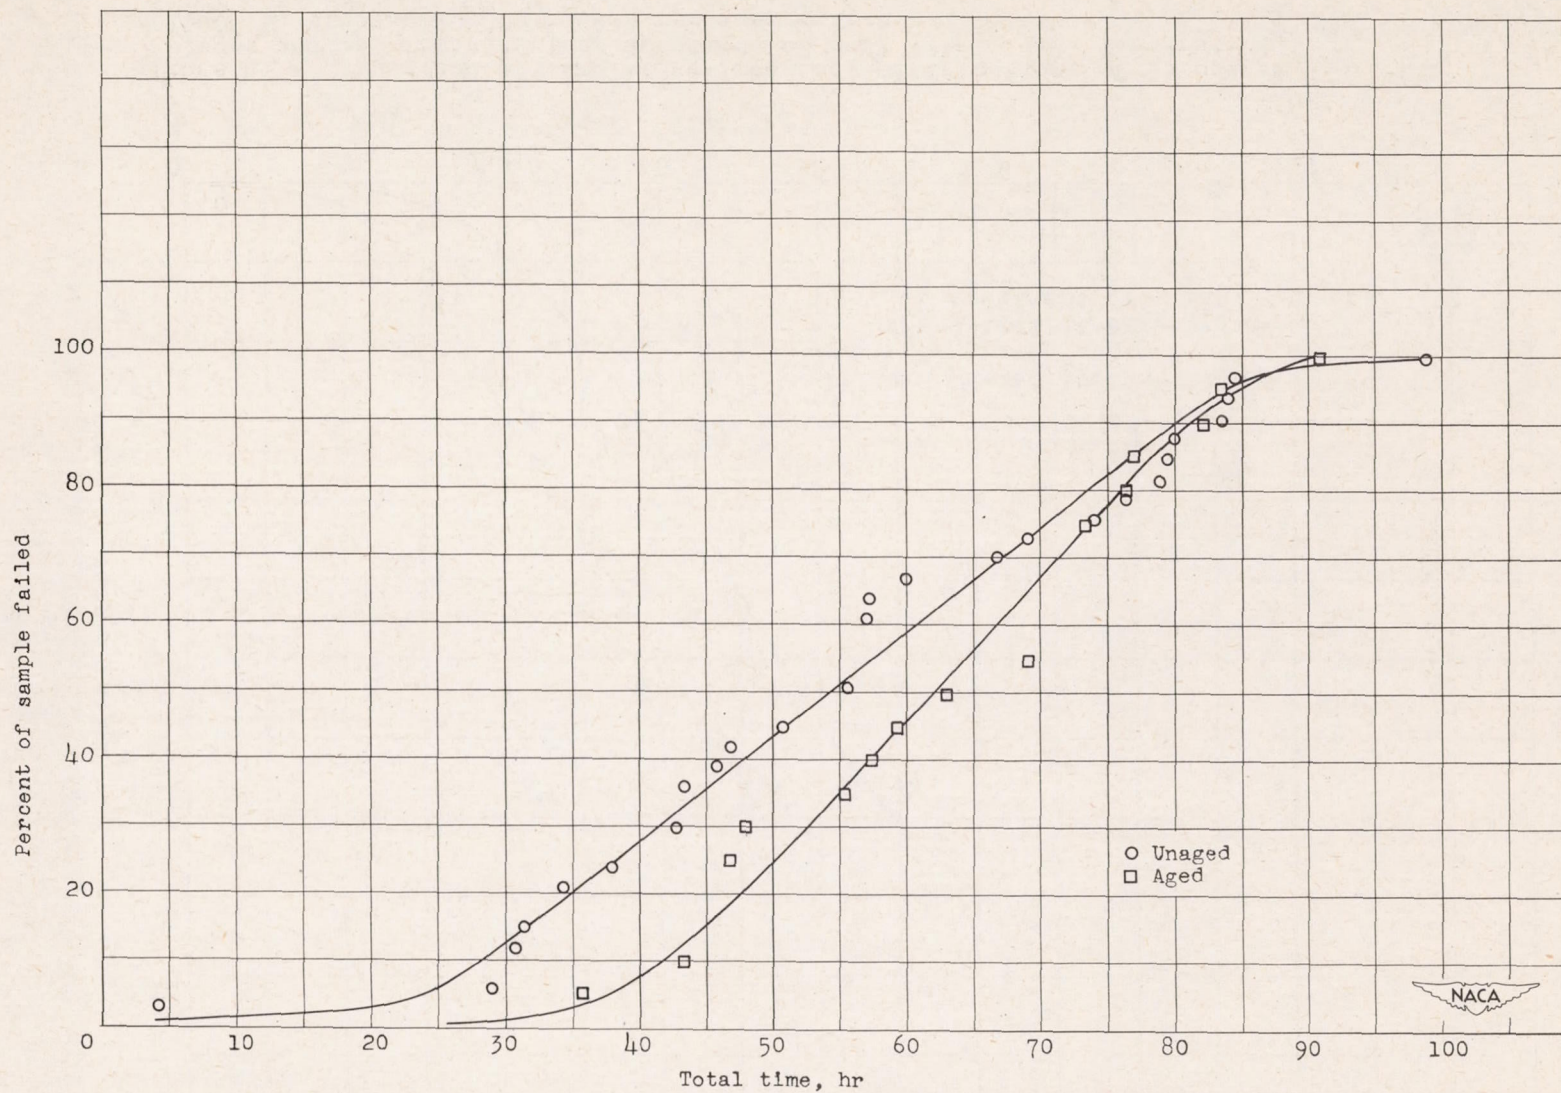
The times for failure for turbine blades of the unaged and aged materials are listed in table I. The failure times for both types of blade are presented in figure 3 as cumulative-frequency (ogive) plots. The data show that aging prior to operation apparently increases the mean life, the uniformity of life, and the time for initial failure of Vitallium turbine blades. These results indicate that aging, which improves stress-rupture strength, increases blade life. The cumulative-frequency data points (fig. 3) also show that after about 73 hours of operation there is little difference in the performance of the two samples, which indicates that aging has not significantly affected the lives of the last blades to fail.

Figure 3. - Cumulative frequency of failures for 33 unaged Vitallium blades and 20 aged Vitallium blades. Temperature, 1500° F; centrifugal stress, 20,000 pounds per square inch in failure-zone cross section.

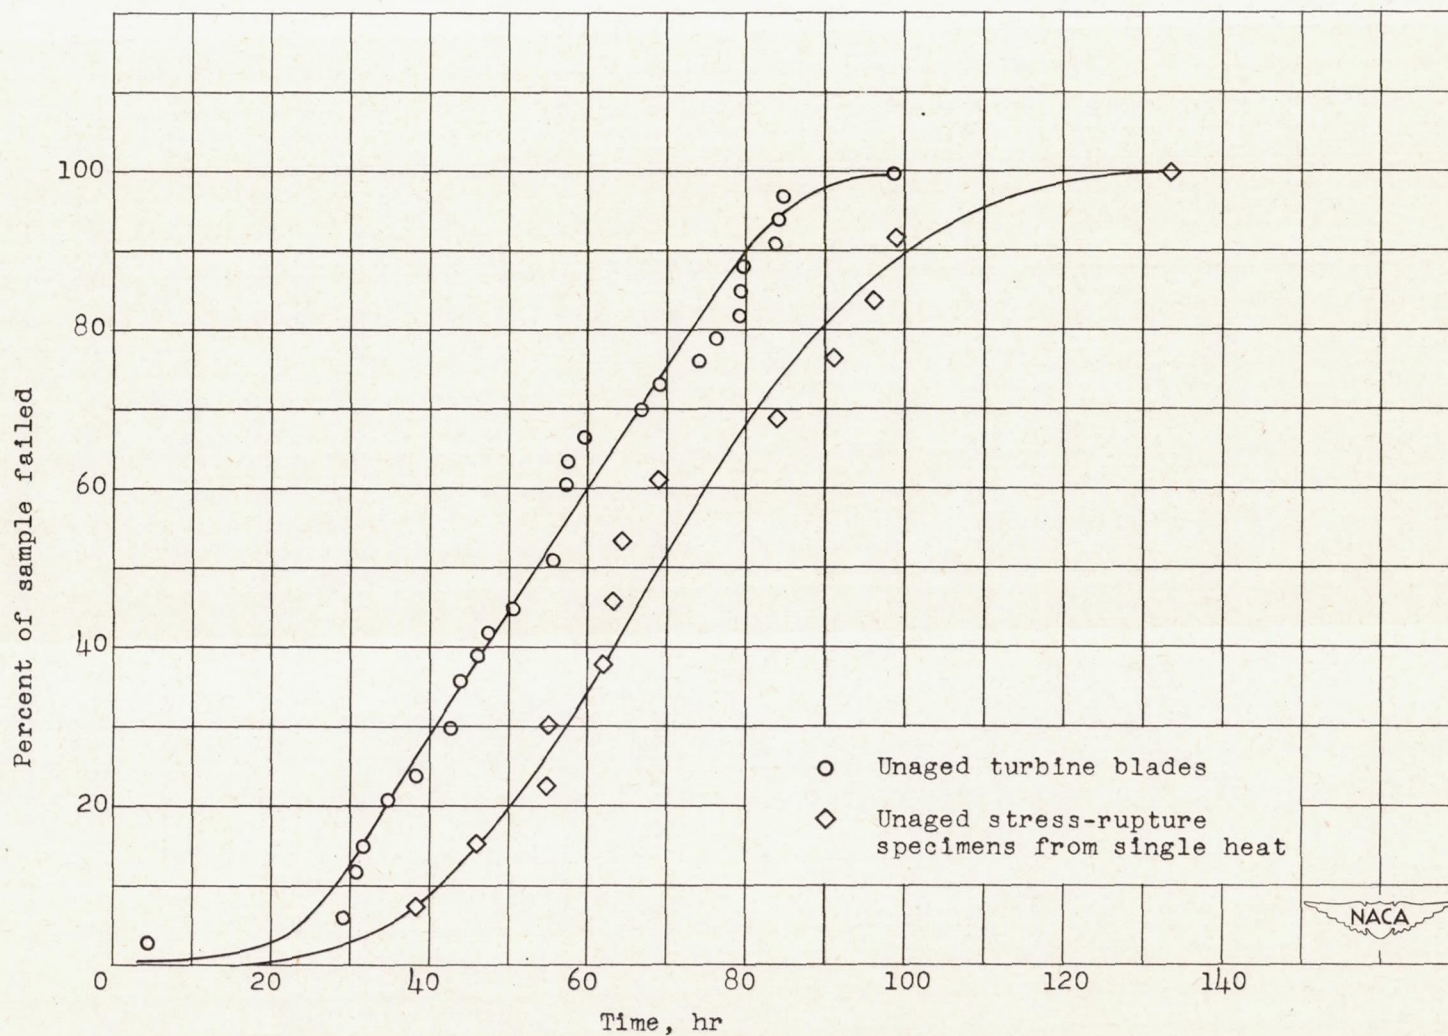
It is of interest to examine the specific manner in which stress-rupture properties of unaged Vitallium, cast in the shape of standard stress-rupture specimens, compare with the behavior of the unaged blades. A tabulation of cumulative failures of unaged Vitallium specimens that failed in stress-rupture evaluations at 1500° F and 20,000 pounds per square inch (plane stress in failure zone of blades) is given in table III; the stress-rupture data were obtained from reference 5. The data of table III are for specimens cast in a single heat; they therefore may be of the same chemical composition. The mean life for the stress-rupture specimen sample is 73.5 hours and the standard deviation is 25.2 hours. The cumulative-frequency curves for these data and for the unaged blades are compared in figure 4. The stress-rupture specimens had a longer mean life than the unaged blades (73.5 hr as compared to 55.2 hr). The standard deviation is slightly greater for the stress-rupture specimens (25.2 hr as compared to 20.7 hr). Calculations indicate that there is a 95-percent probability that the stress-rupture-specimen population mean is greater than 63.9 hours and that the unaged-blade population mean is less than 61.1 hours. It can therefore be concluded that there is a significant difference in population means. Also, computations indicate that there is a 95-percent probability that the actual standard deviation for the unaged-blade population will be no greater than 27.6 hours; hence, it is seen that the deviation for the stress-rupture specimen could be the same or approximately the same as that for the unaged-blade-sample standard deviation. Inasmuch as both samples may have about the same dispersion, there is a possibility that the same systematic causes of failure operate in both instances, but about different levels. An accurate comparison, however, can be made only with a larger number of items in both samples. Figure 4 can support this theory inasmuch as the two ogive curves are similar in shape and dispersion, but are displaced. Thus, there is an indication that stress-rupture data may be a primary criterion in determining blade life in a small gas turbine of the type used in this investigation.

Figure 4. - Comparison of cumulative-frequency distributions of 33 unaged blades and 13 stress-rupture specimens of cast Vitallium. Temperature, 1500° F; stress, 20,000 pounds per square inch.

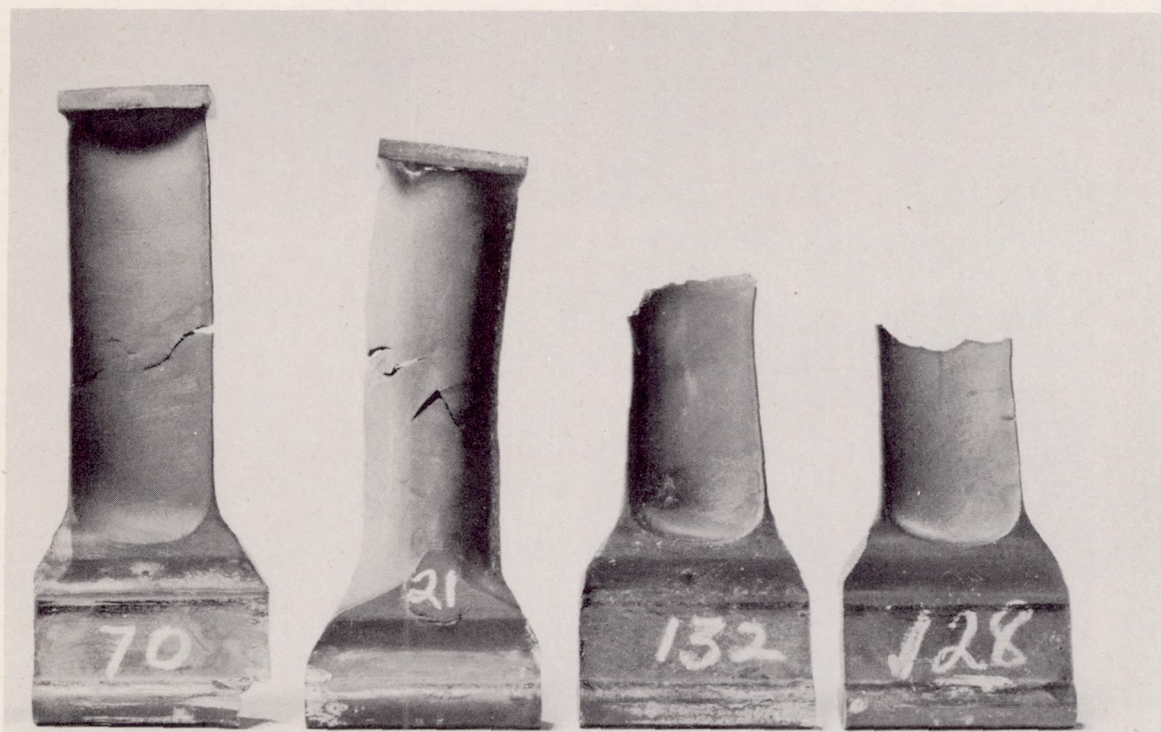
Figure 5. - Typical blade failures. X2.

Typical failures are shown in figure 5. The failure zone lies midway along the airfoil length. Figure 5(a) illustrates a blade that was removed because of severe cracking. It manifests no necking, but appears to have cracked at both edges and at the center. Figure 5(b) shows a blade that cracked at the center and one edge only. Because of the displacement of the center of area consequent to cracking, centrifugal force has bent the blade. Figure 5(c) illustrates the necking of a blade and the subsequent fracture at a point outside the region of necking. This behavior is typical of the blades that failed after necking occurred. Figure 5(d) illustrates cracking and necking outside the failure zone. These modes of failure are typical of both aged and unaged blades.

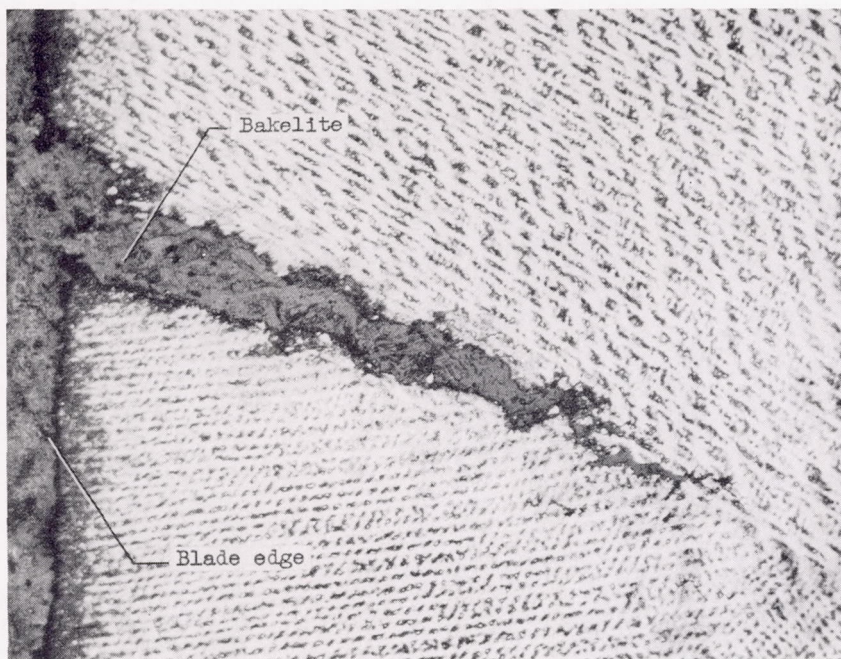
Examination of the failures of both samples indicated that cracks started in the grain boundaries and became transcrystalline as they progressed. A typical intergranular edge crack is shown in figure 6. Intergranular surface cracks also occurred at the center of the blades. This microstructural evidence indicates that under the temperature and stress conditions of this investigation, the failure progresses in its early stages along the grain boundaries. It is not known whether transcrystallinity is characteristic only of the later stages of rupture, or is present at an earlier stage. Thermal stresses apparently were not severe, because no blade warping was noted.

Figure 6. - Typical intergranular crack at edge of blade. Electrolytically etched in 10-percent nitric acid and 10-percent ethylene glycol in ethyl alcohol. Vertical illumination. X50.

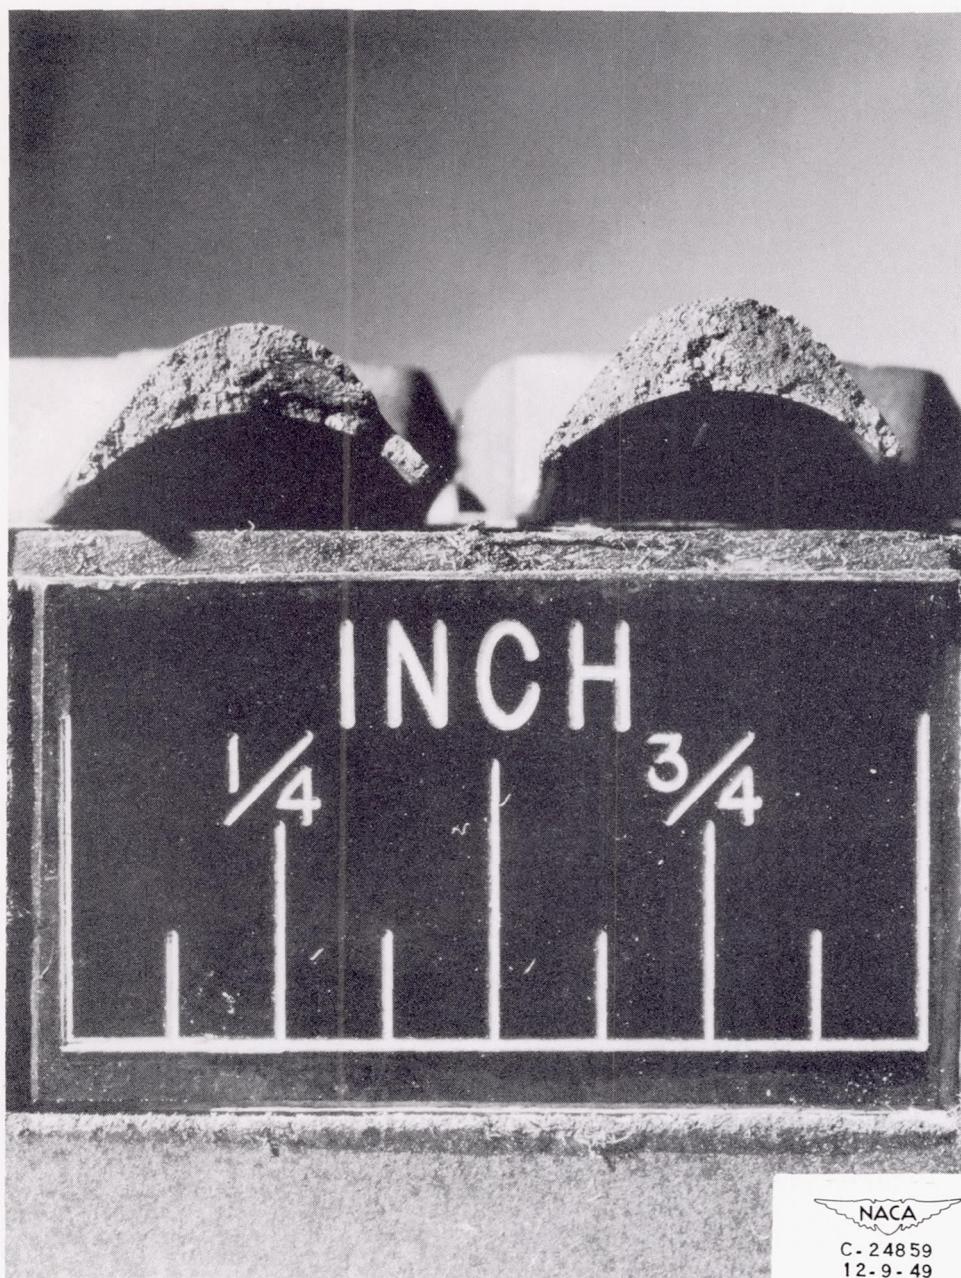
The textures of failure surfaces are exemplified by those shown in figure 7. The coarse crystalline surface was observed in all failures. The surface was divided into two distinct zones manifesting different oxide colors, one a dark gray and the other ranging in color from light straw to deep blue. The gray zone was present in the area where cracking first occurred; whereas the other colors were observed only on freshly fractured surfaces. There was no evidence of a fatigue type of failure in any of the fractures and, from the nature of the fractures, stress rupture is probably the major cause of failure. It is impossible from the results of this investigation to determine the extent of other factors, such as thermal shock or vibration, and whether or not they are contributing causes of failure.

Figure 7. - Blade-fracture surfaces showing coarse crystalline texture.

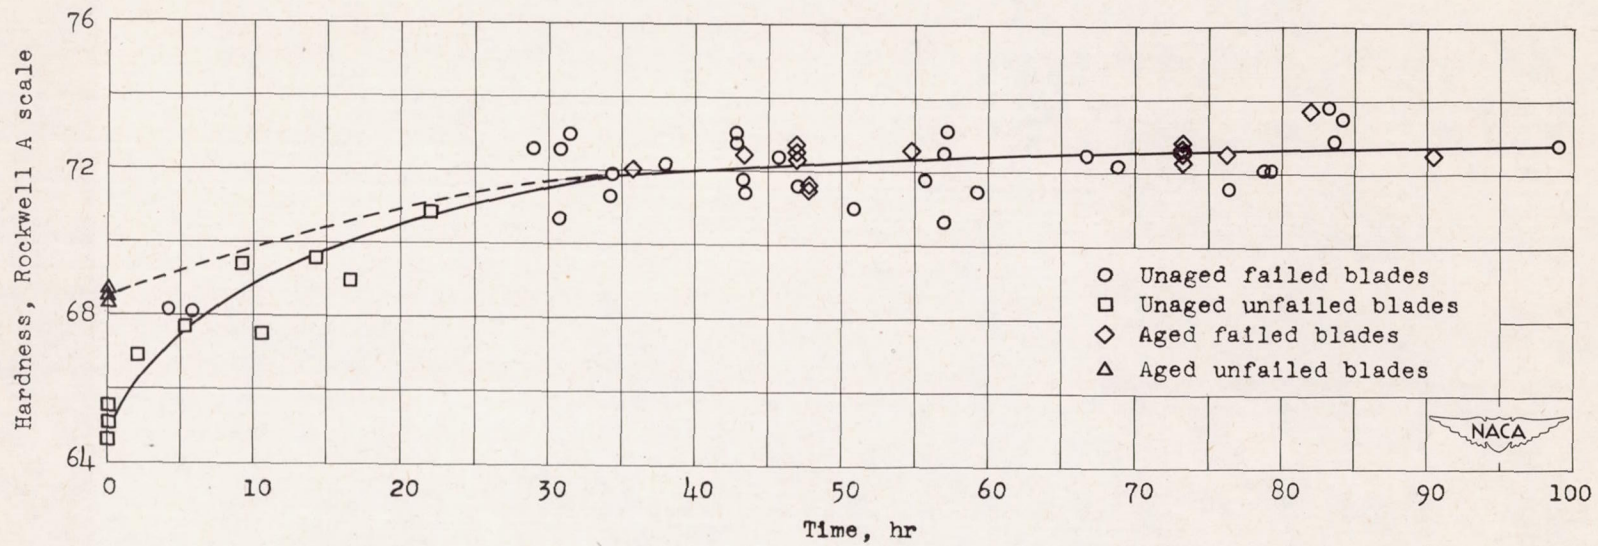
The results of hardness determinations on both types of blade after turbine operation, as well as blades that had not failed, are presented in figure 8. Each point on the graph represents an average value of five readings distributed over the blade cross section. It should be noted that the unaged blades hardened rapidly and reached the same hardness as the aged blades that had not failed in about 9 hours. The presence of high stresses possibly contributed to the rapid aging. The presence of stress is known to accelerate aging in light alloys (reference 6), but it is not conclusively known whether high-temperature alloys of the Vitallium type are so affected. Both sets of used blades attained the same hardness after about 35 hours of operation, and the hardness increased slightly at approximately equal rates thereafter. These results show that failure of some unaged blades occurs before the blades reach the point where the hardness increase levels off (35 hr). No aged blades, however, failed before 35 hours, which indicates that preoperation aging resulted in the blades becoming almost fully hardened before failure. The aging period of 48 hours at 1500° F was selected to yield good stress-rupture properties (reference 1). It is apparent from the hardness data, however, that aging before operation was only partly complete. The attainment of a higher preoperation hardness might further improve performance.

Figure 8. - Variation of hardness of turbine blades with time of operation.

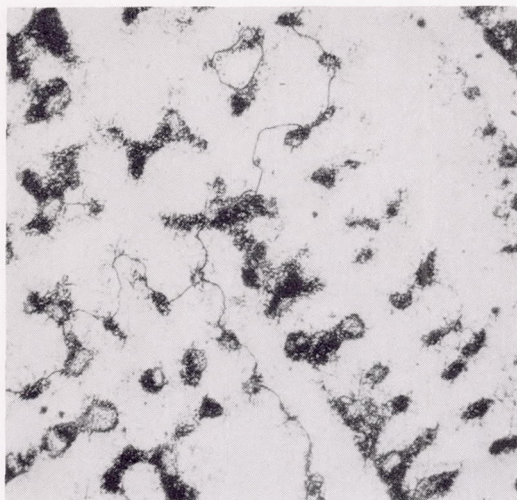
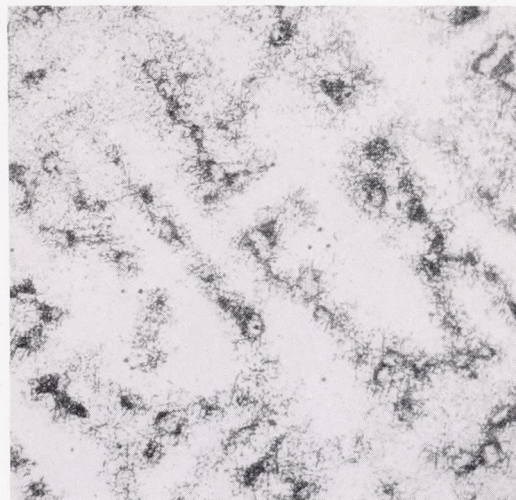
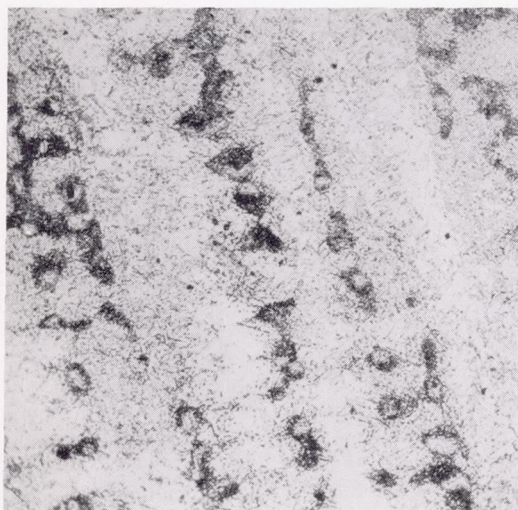
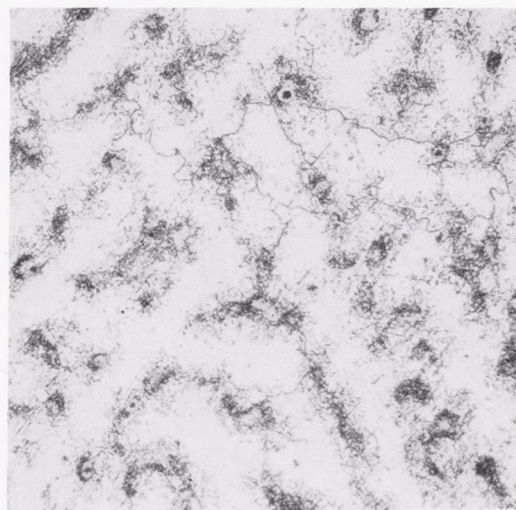
Photomicrographs of unaged blades before turbine evaluation and after failure, at times ranging from 4.3 to 84.2 hours, are presented in figure 9. Figure 10 shows the structures of aged blades before evaluation and after failure at times ranging from 35.8 to 90.8 hours. The unaged material shows no precipitate before engine operation (fig. 9(a)); a precipitate is clustered about the original microconstituents after 4.3 hours of operation (fig. 9(b)); further operation shows a greater tendency for the precipitate to penetrate the matrix. By comparison, the aged sample before operation shows a precipitate close to the microconstituents (fig. 10(a)) and all aged blades that were examined after failure had a precipitate extending into the matrix. The evidence of the precipitate serves to corroborate the hardness data.

Figure 10. - Microstructure of aged blades before turbine evaluation and at various failure times, showing stages of precipitation. Electrolytically etched in 10-percent nitric acid and 10-percent ethylene glycol in ethyl alcohol. X250.
